ST1300 Window Adjustment Mechanism Removal

This document shows step by step instructions for removal of the ST1300 Window Adjustment Mechanism (Honda Part# 64170-MCS-G01). As more owners report mechanism failure, it is becoming clear that regular removal, inspection, cleaning, lubrication and possible gear replacement is required to assure a working unit. The OEM mechanism has 3 primary failure modes; one often leads to the other.

Part#1 Windshield mechanism removal

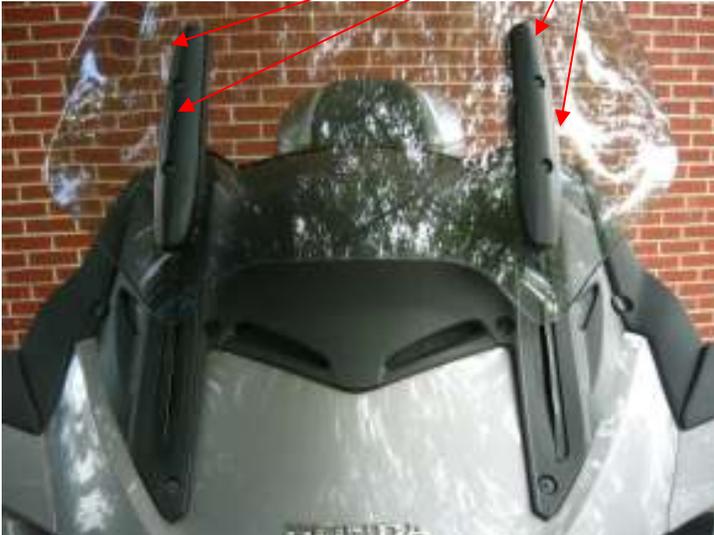
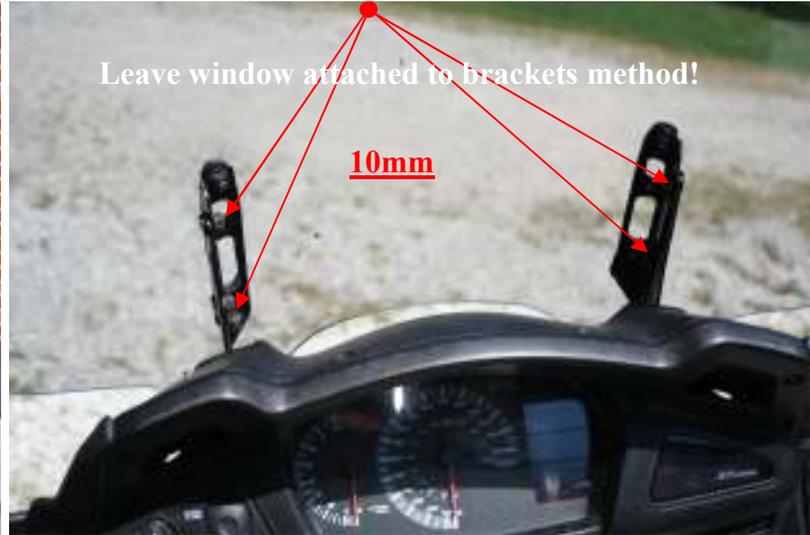
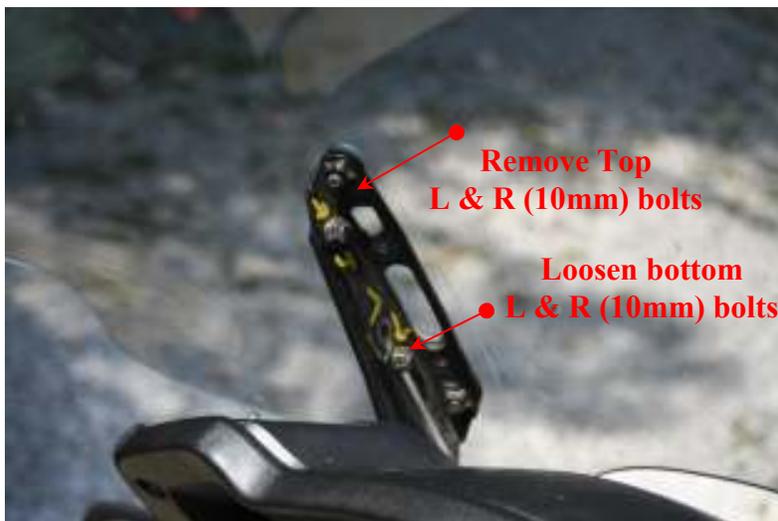
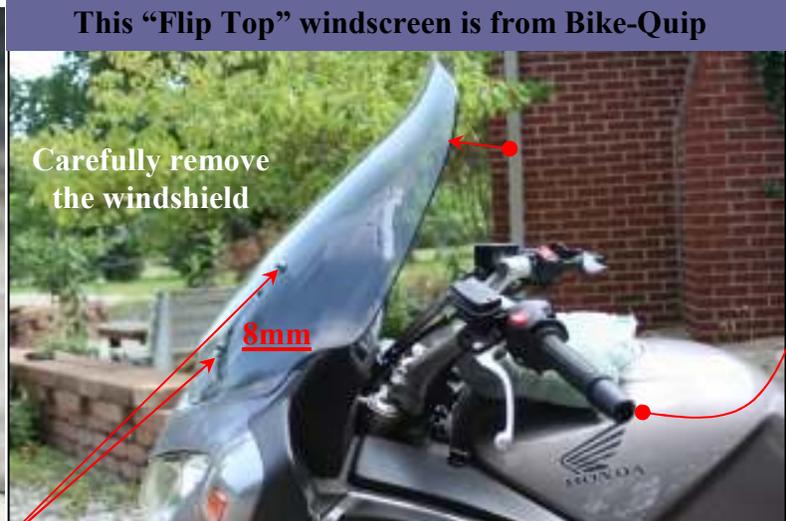
- 1) Put the windshield full up. (unless stuck in lower positions / see below) *
- 2) Remove 4 Philips plastic cover screws (2L,2R)
- 3) Remove brackets from window "arms" by removing 4 bolts (10mm)(2L,2R)
(Leave brackets on windshield)

* Alternately (if stuck in lower positions) 1st remove windshield from brackets 4 (8mm) bolts (2L,2R) then go back to step#3; "remove brackets from window arms".

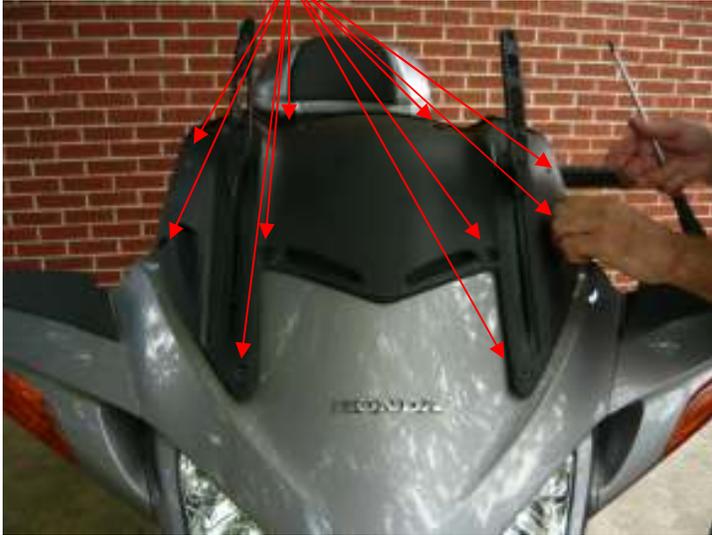
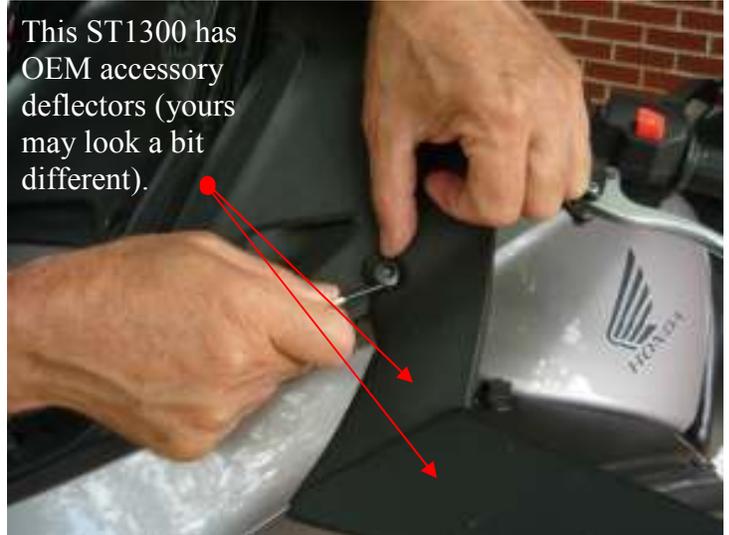
4) Remove all plastic retainers (8pcs) from front black (push in centers pry or pop out. The idea here is to remove the black nose piece.....find them all, pop them out

This ST1300 has OEM accessory deflectors (yours may look a bit different).

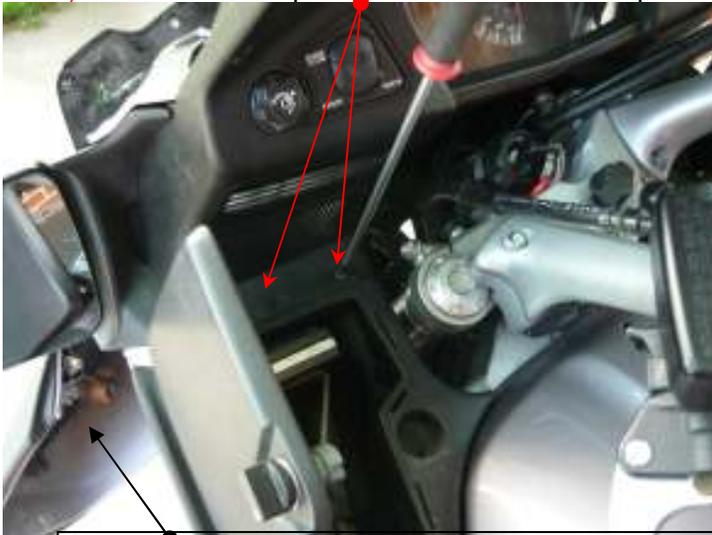
5) Remove 4 Phillips screws from instrument panel 2-L side 2-R side

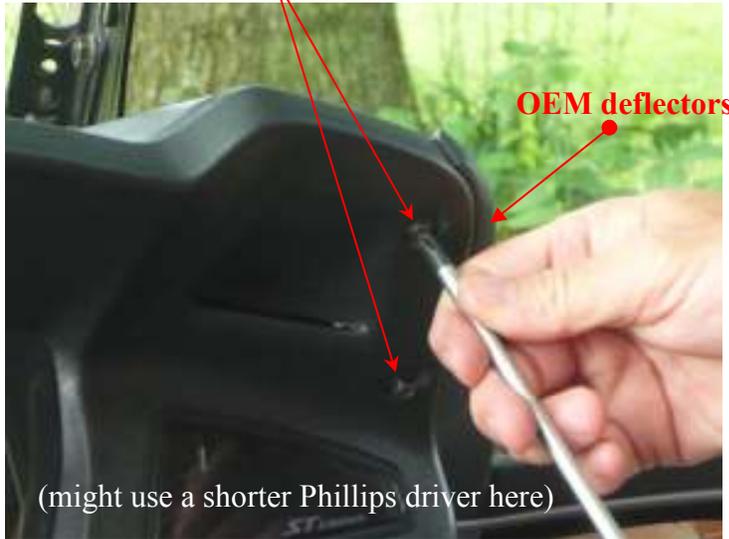
6) Remove 4 Phillips screws from instrument panel 2-L side 2-R side

OEM deflectors

(might use a shorter Phillips driver here)

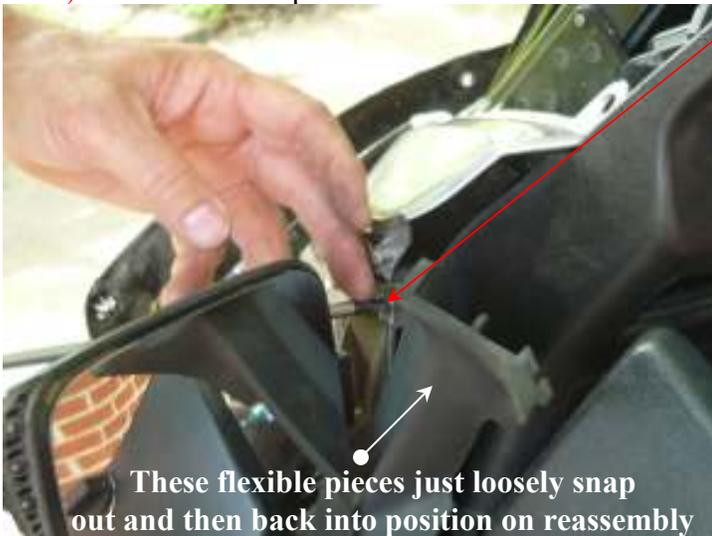
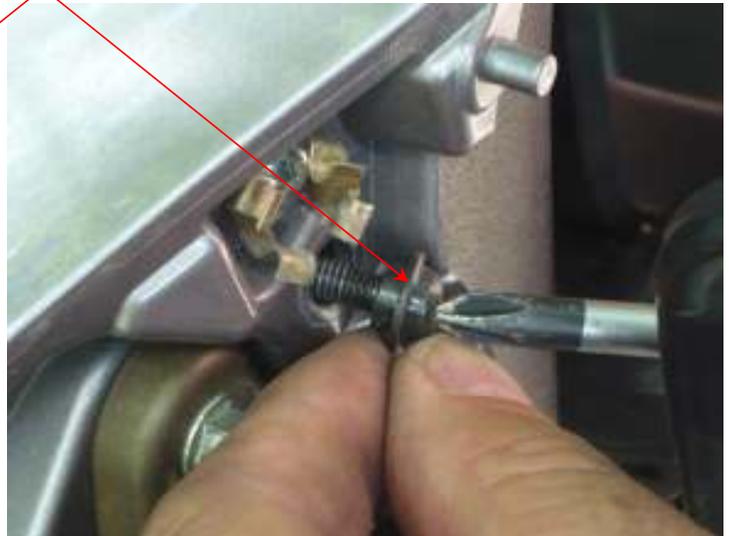
Shown with mirror housings removed (just give them a good "hit" with the palm of your hand) they will hang harmlessly by plastic cord.

7) Remove 1 Phillips bolt from each side above mirrors

These flexible pieces just loosely snap out and then back into position on reassembly

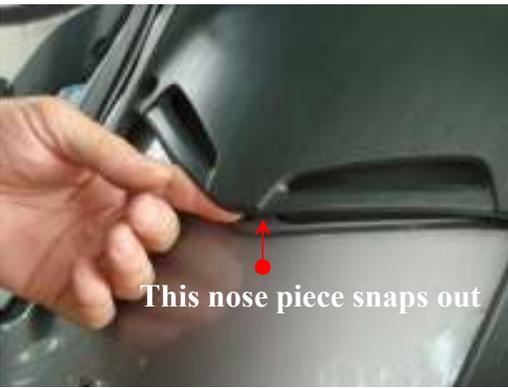
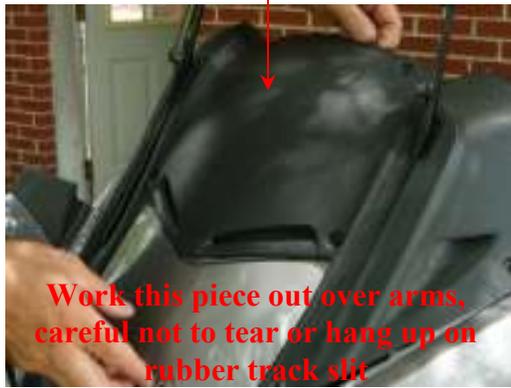
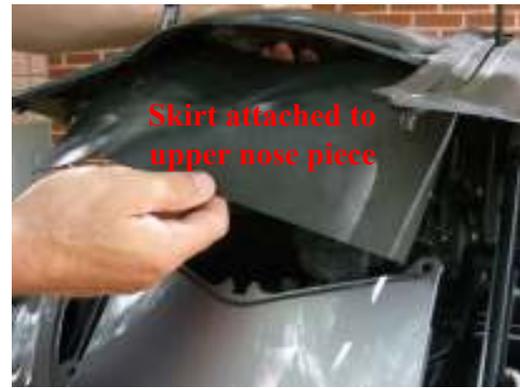
8) Remove the front black plastic upper nose piece with skirt attached over arms...be careful not to hang up on slits

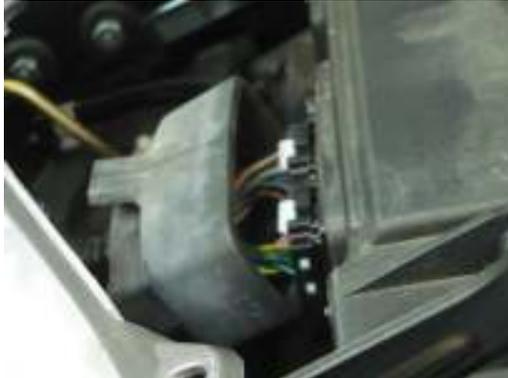
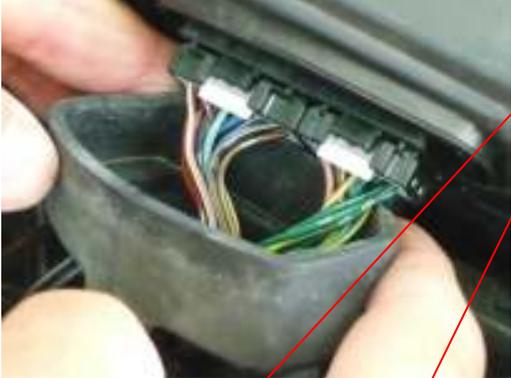
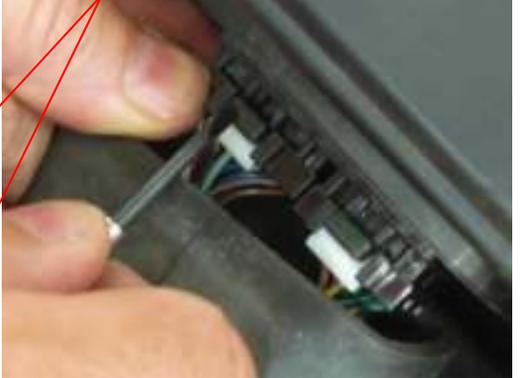
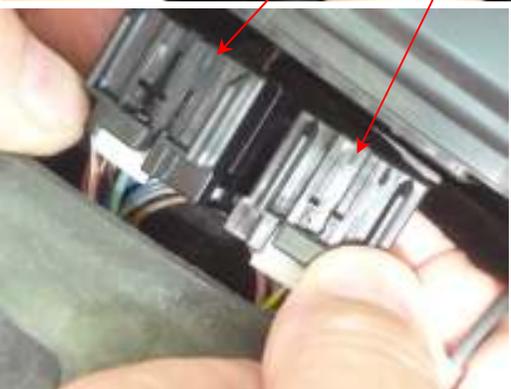
9) Pull rubber housing away and disconnect 2 side by side electrical connectors

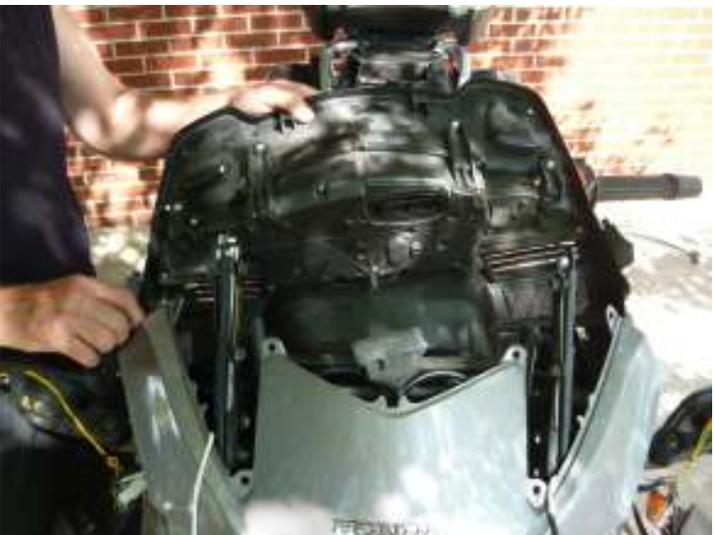
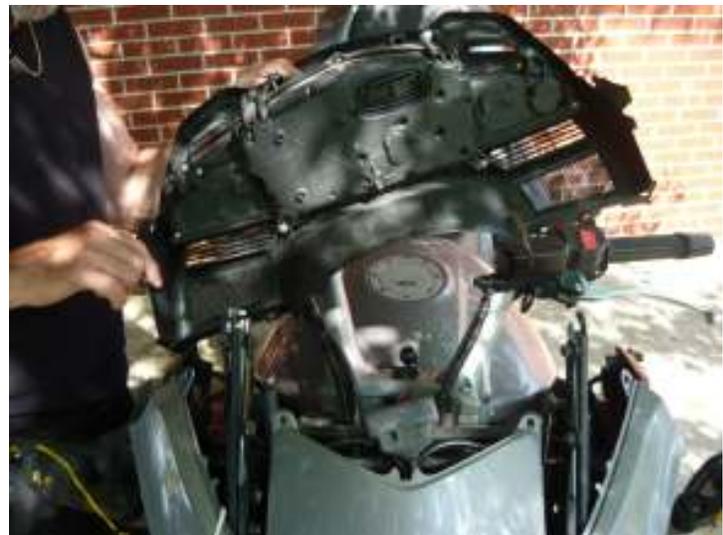
10) Remove Dash..... Piece of cake!

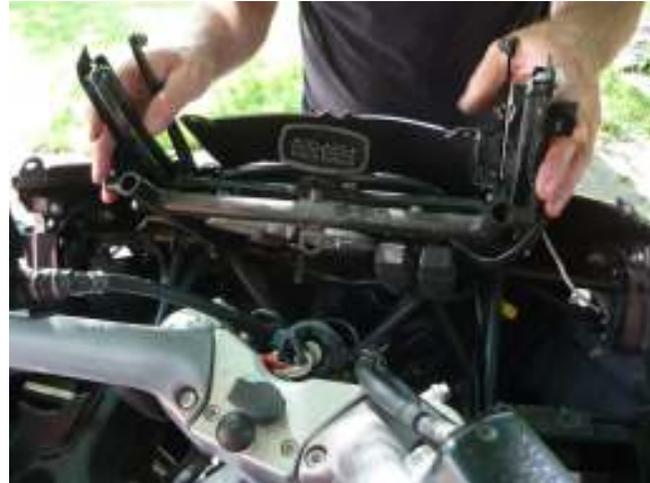
With the Windshield, Dash and Nose piece removed, you can start to see that the hardest part of disassembly is over. Take a breath....maybe have a cold one. A few more bolts will have the window adjuster assembly out and on the bench for cleaning and drive gear replacement.

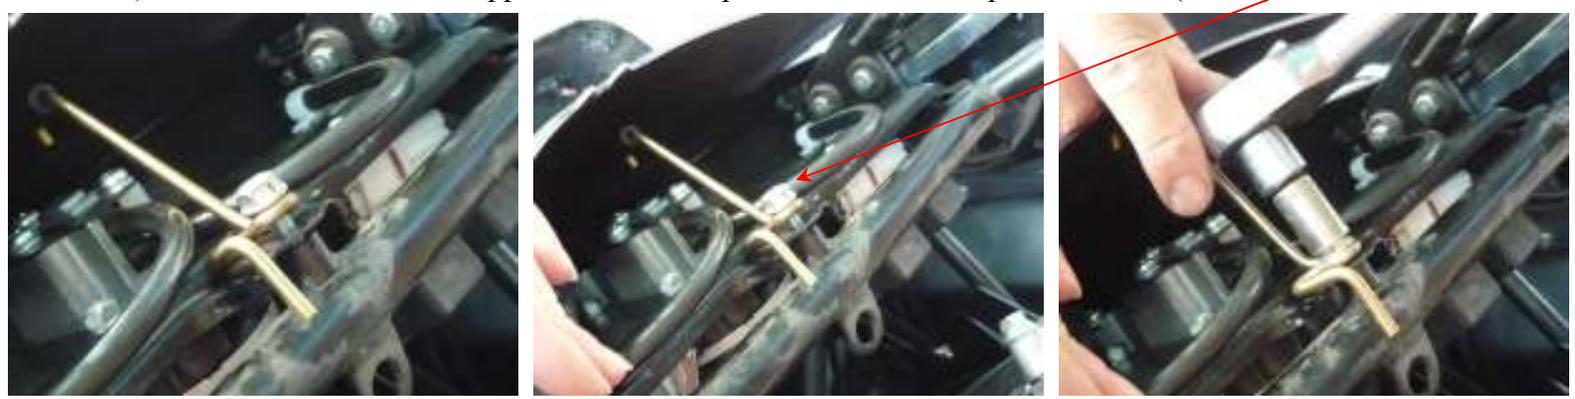
11) Remove bolt and rubber tipped formed wire piece that holds nosepiece forward (10mm)

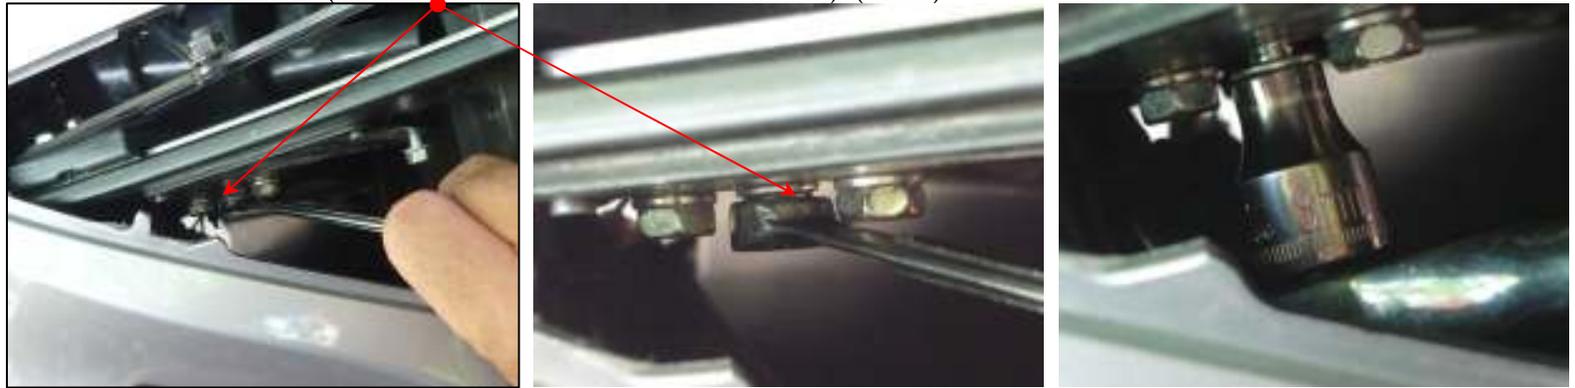
12) Remove 2 lower bolts (1L & 1R) from each side of assembly
----Lower mount (the middle bolt on each side as shown) (8mm) ... wrench or short socket will work

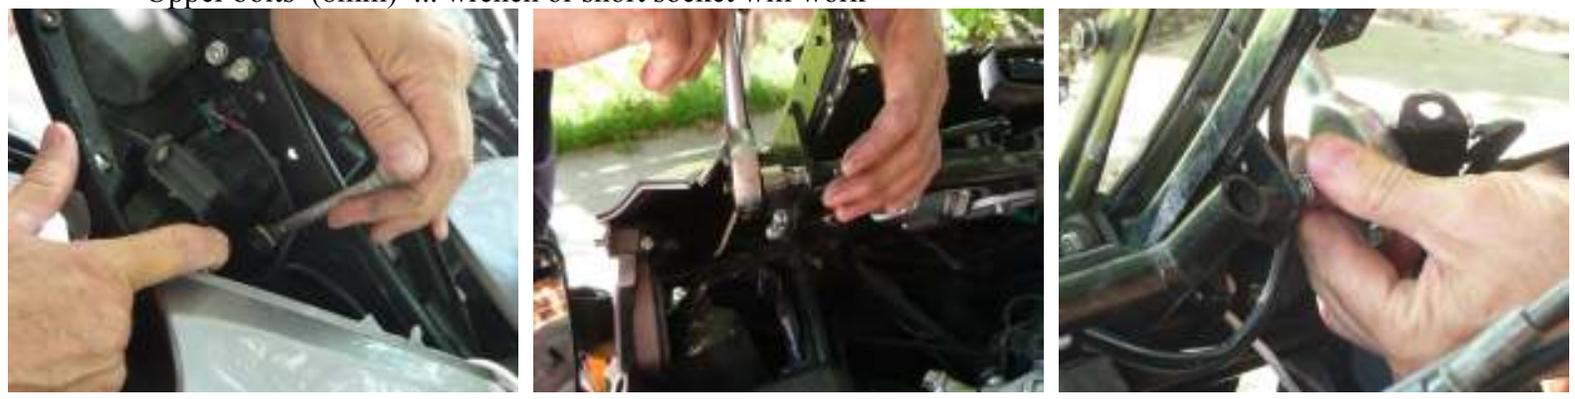
13) Remove 2 upper bolts (1L & 1R) from each side of assembly
----Upper bolts (8mm) ... wrench or short socket will work

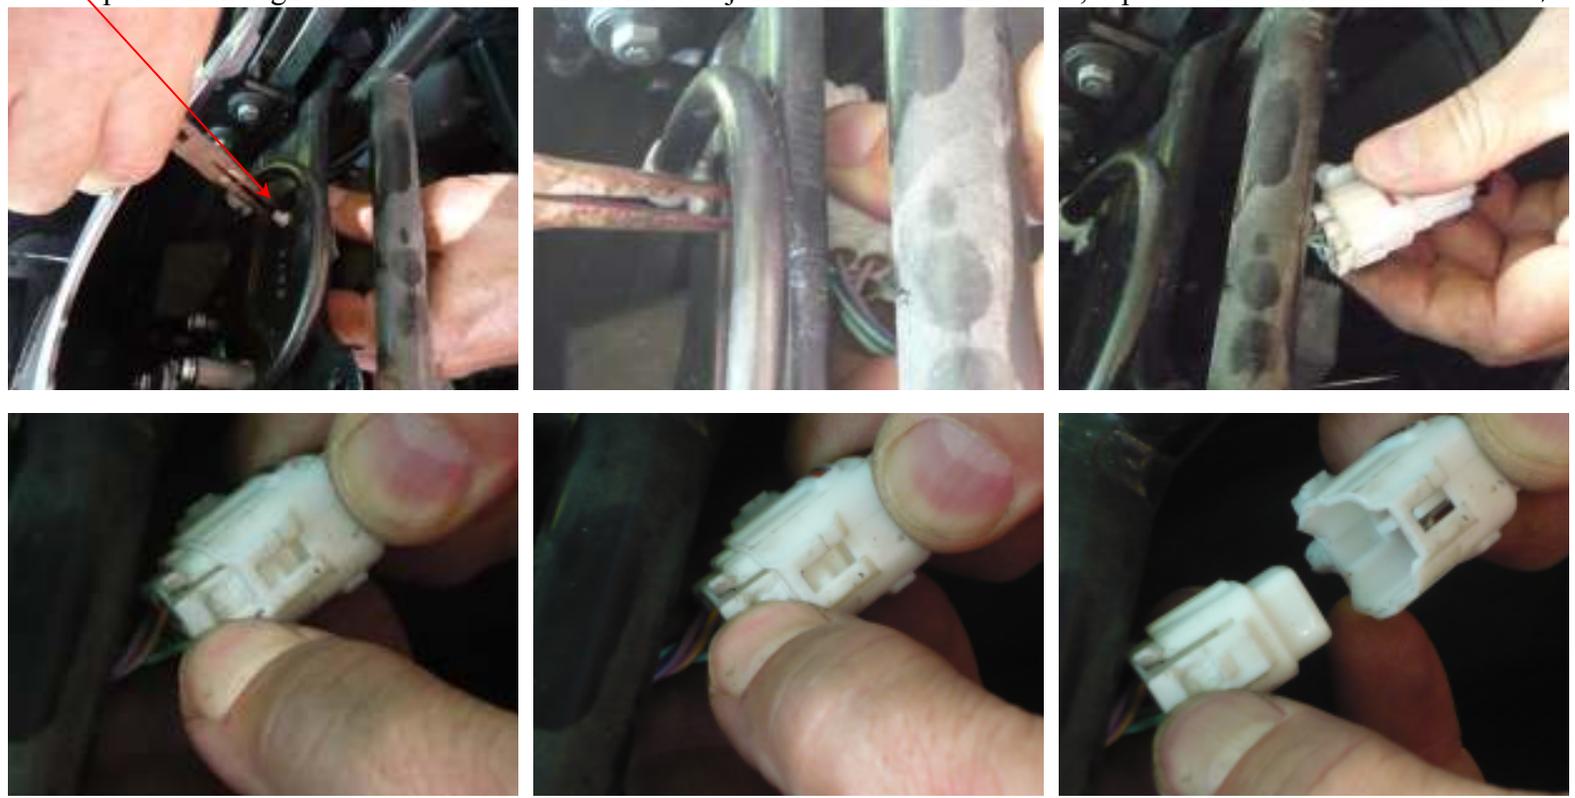
14) Remove the window adjustemnt mechanism electrical connection by first pushing the white plastic clip portion through the frameonce the connector joint is free from the frame, seperate the connector as shown

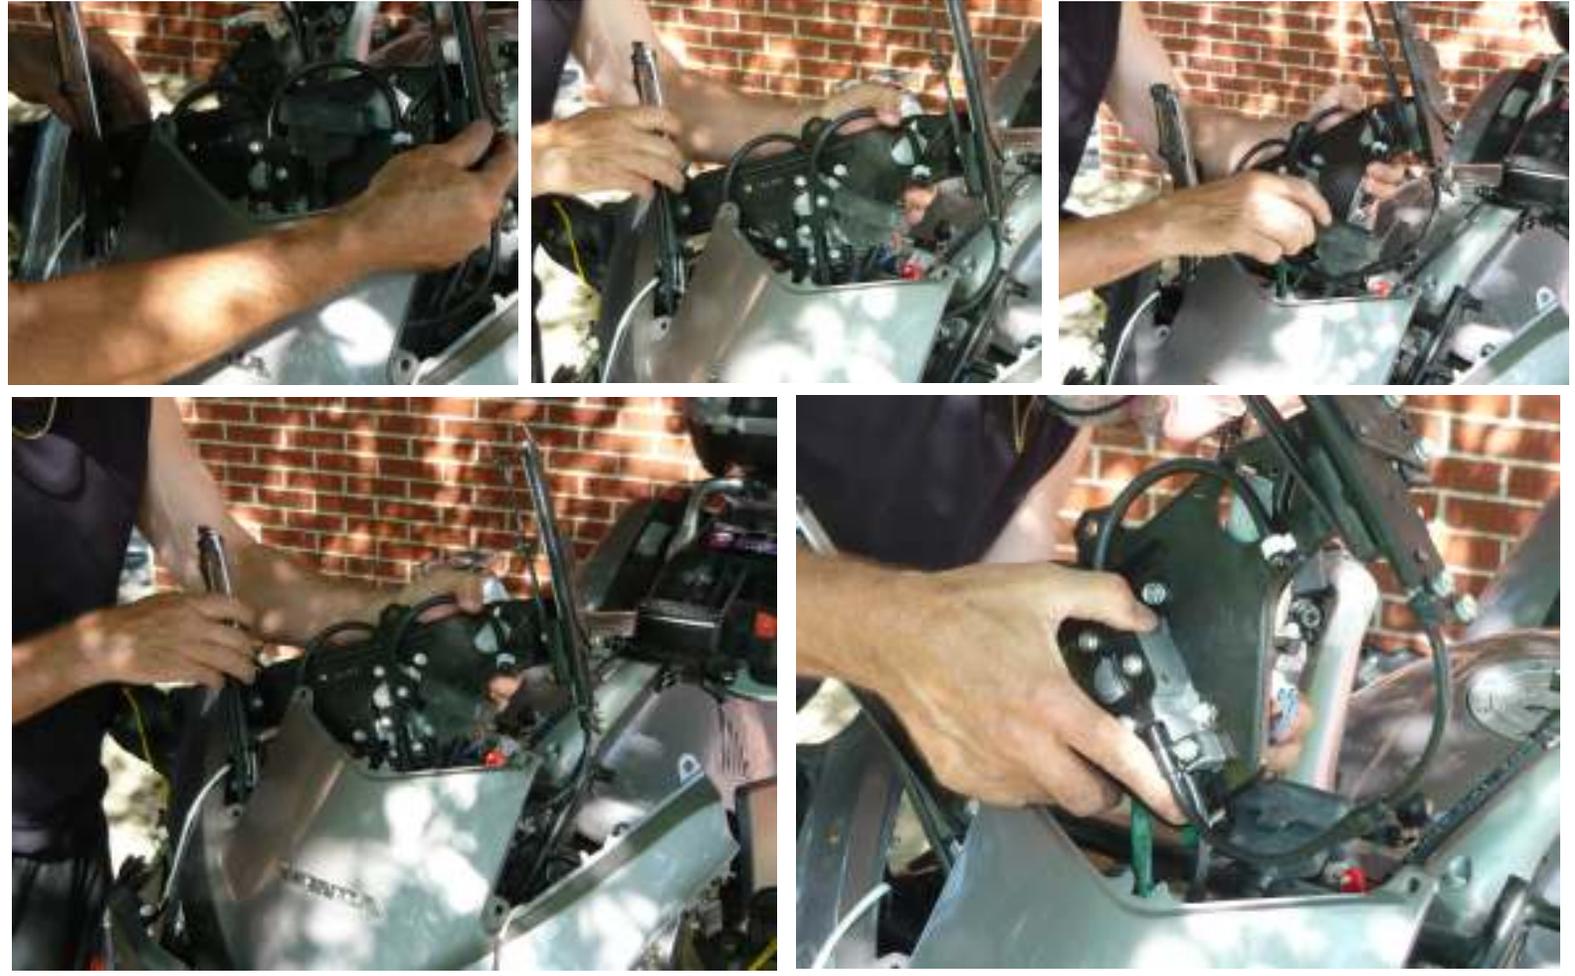
15) Remove the window adjuster assembly. Might have to rock-it back & forth a bit, just walk it out.A little tight but nothing to worry about.....
